MLPA 2020

Snow load

Doesn't always mean collapse

It isn't always covered

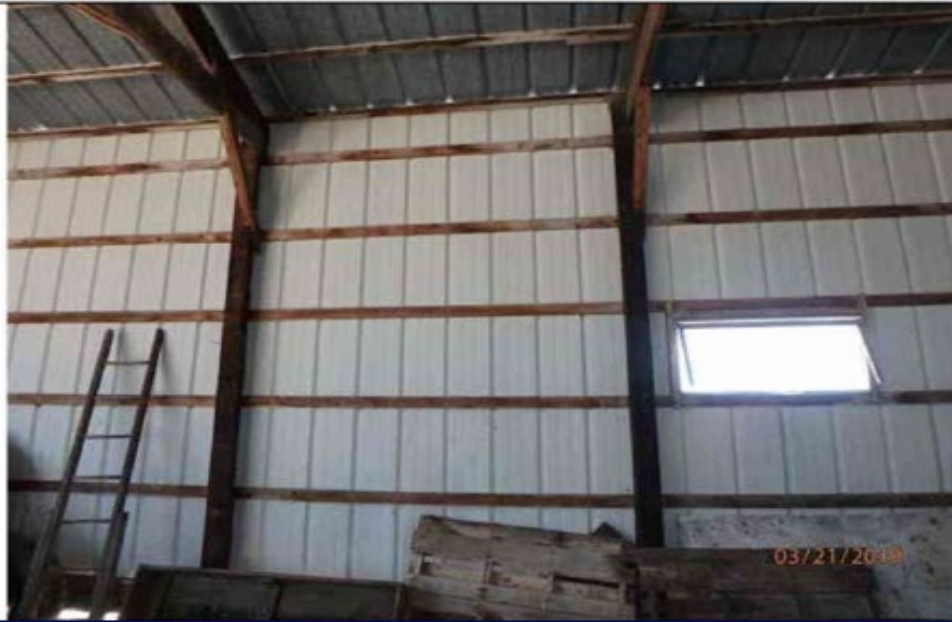
Photo 7: Typical wall framing.

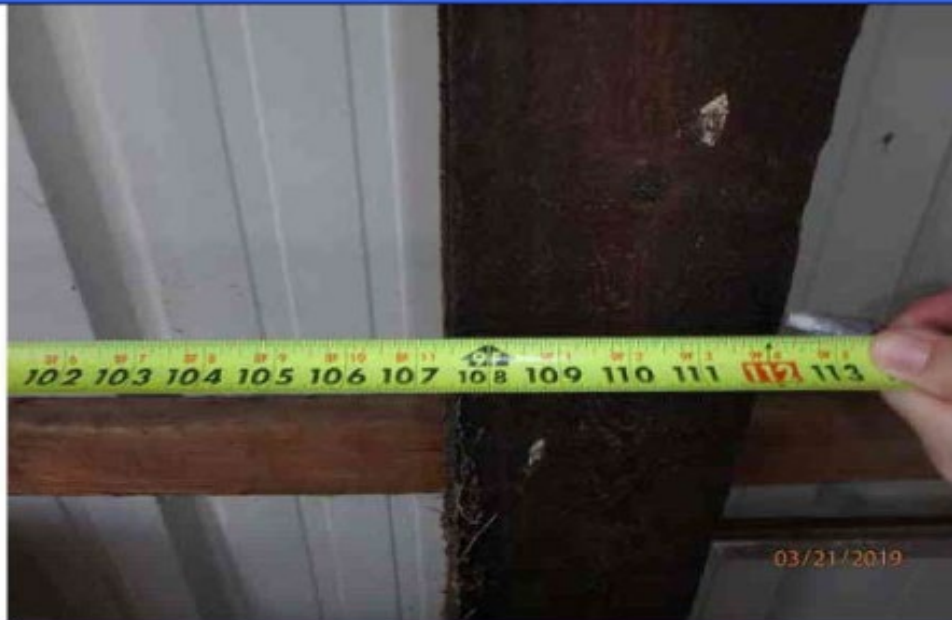
Photo 8: Column/truss spacing.

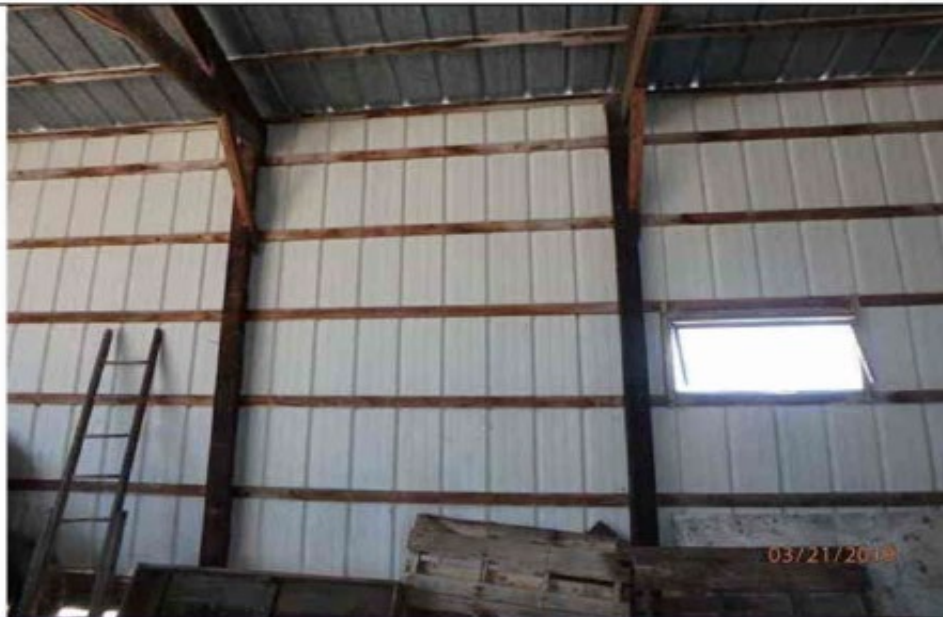
Photo 7: Typical wall framing.

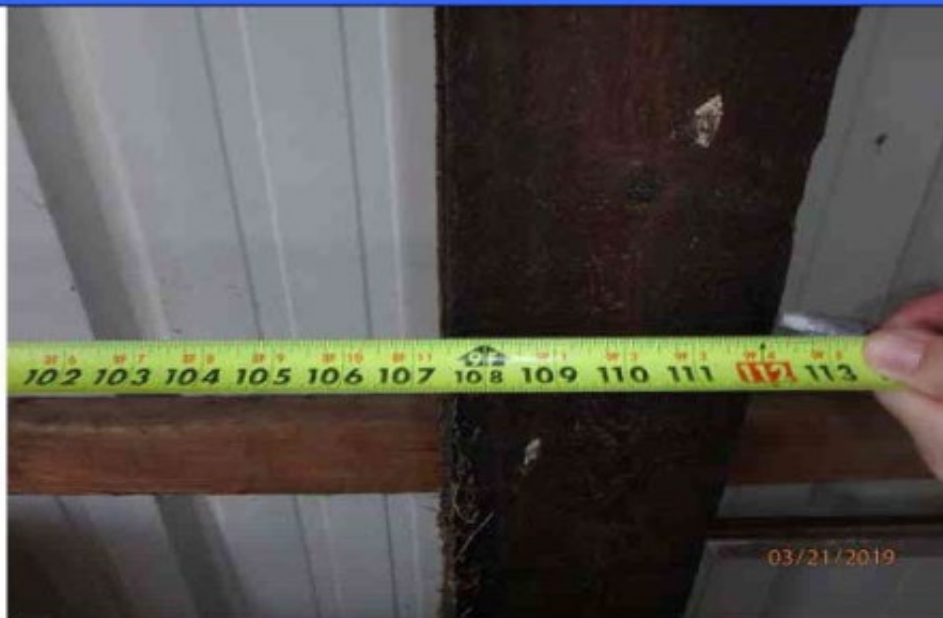
Photo 8: Column/truss spacing.

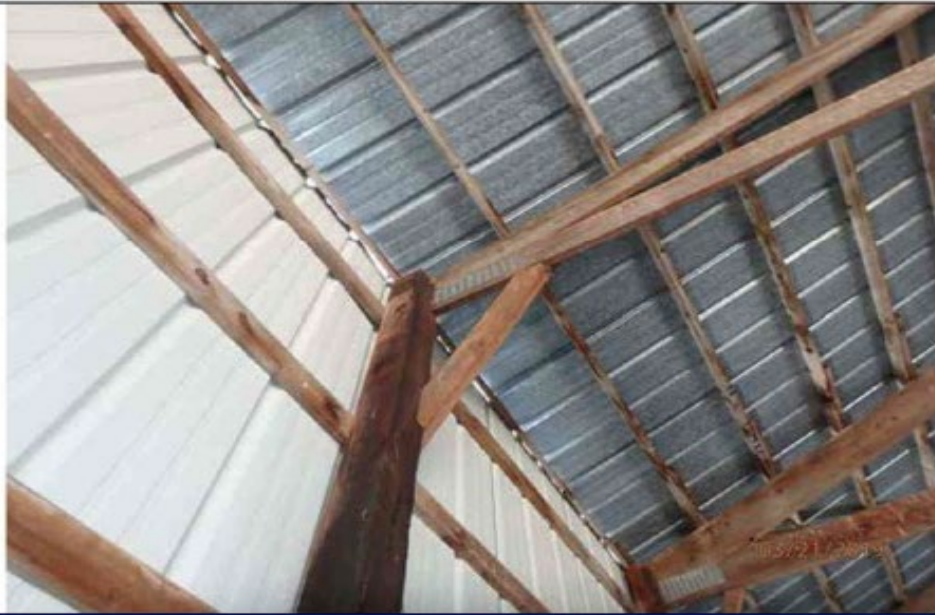
Photo 9: Typical
column/truss
connection.

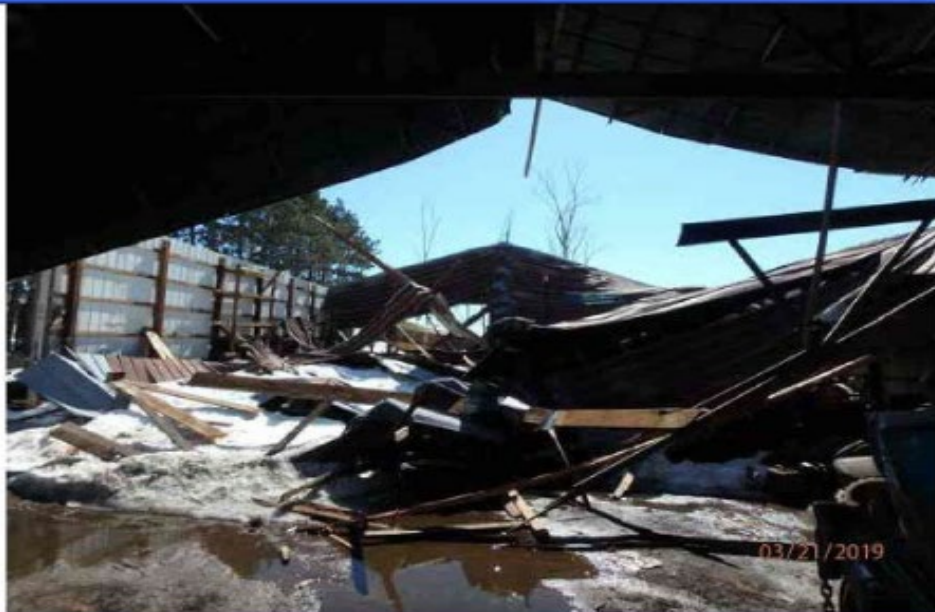
Photo 10:
Overview of
collapsed debris
field facing south.

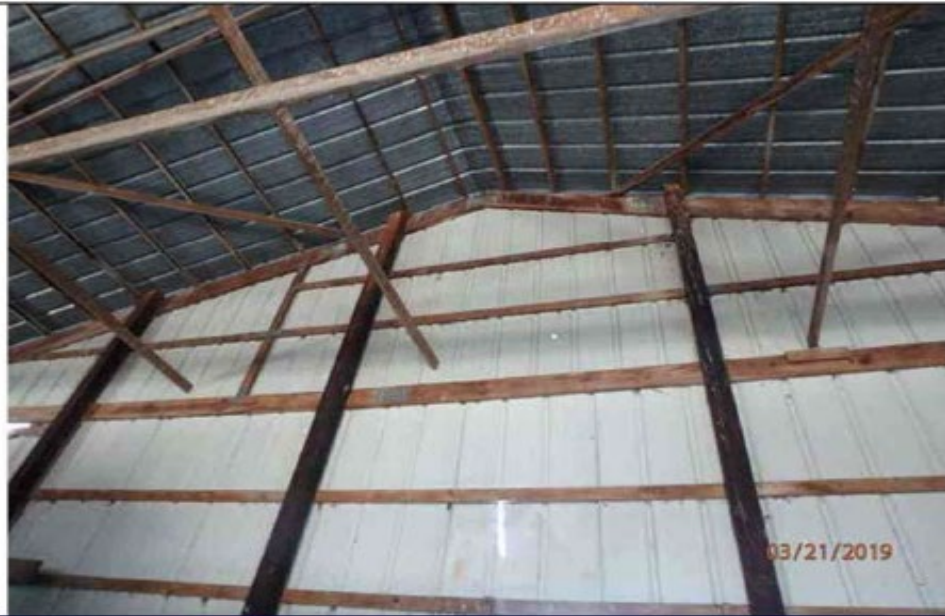
Photo 13: Detached bracing at north wall.

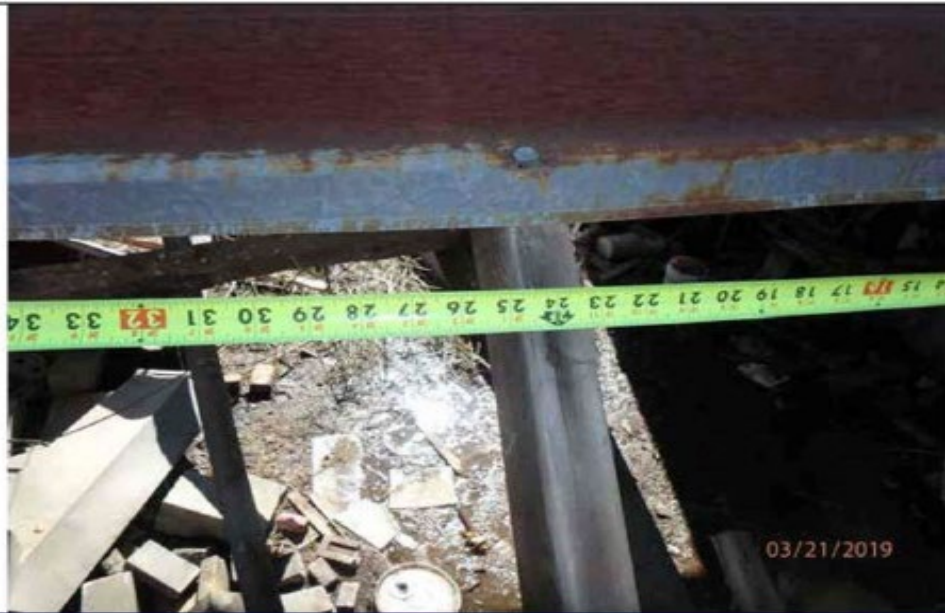
Photo 17: Purlins spaced at 24" o.c.

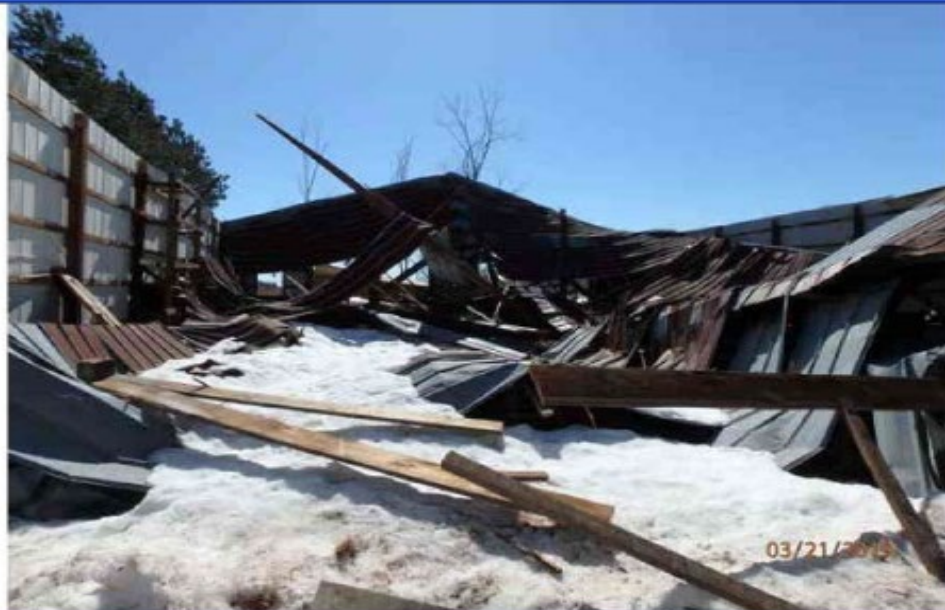
Photo 18: Snow build-up east side of building.

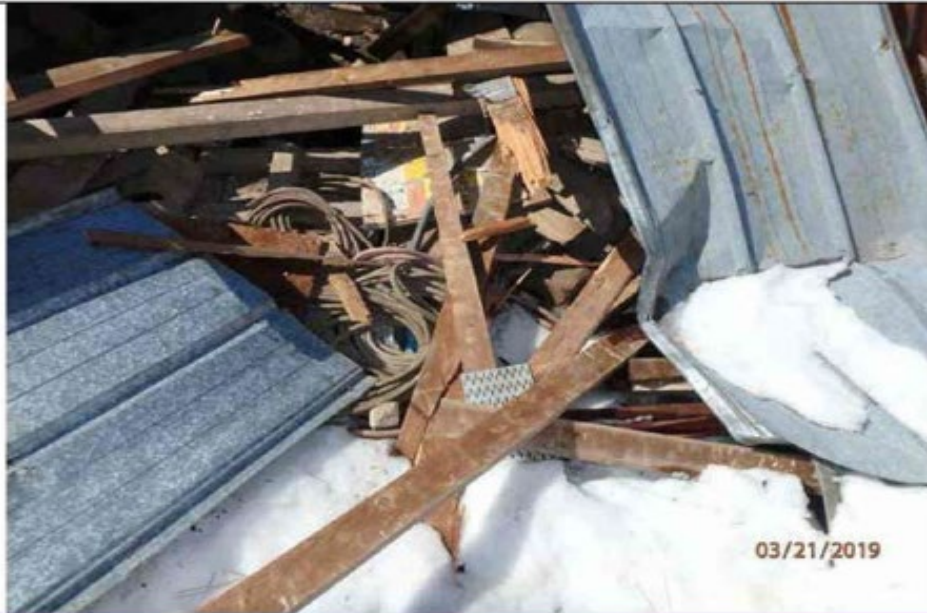
Photo 19:
Fractured truss
members.

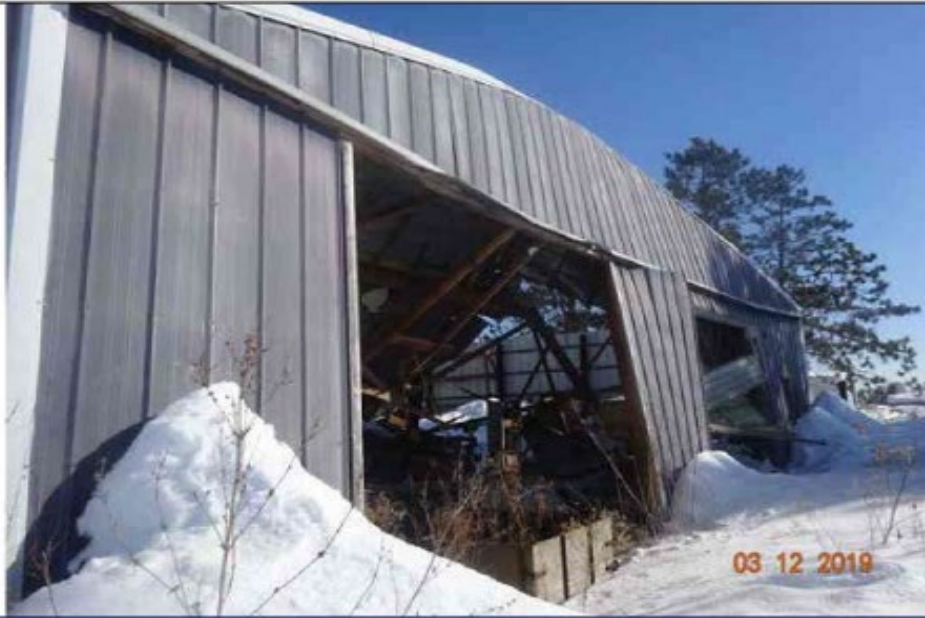
Photo 21:
Displaced south
wall.

Note: Image
provided by Little
Black Mutual
Insurance. Image
captured 2 days
after collapse
event.

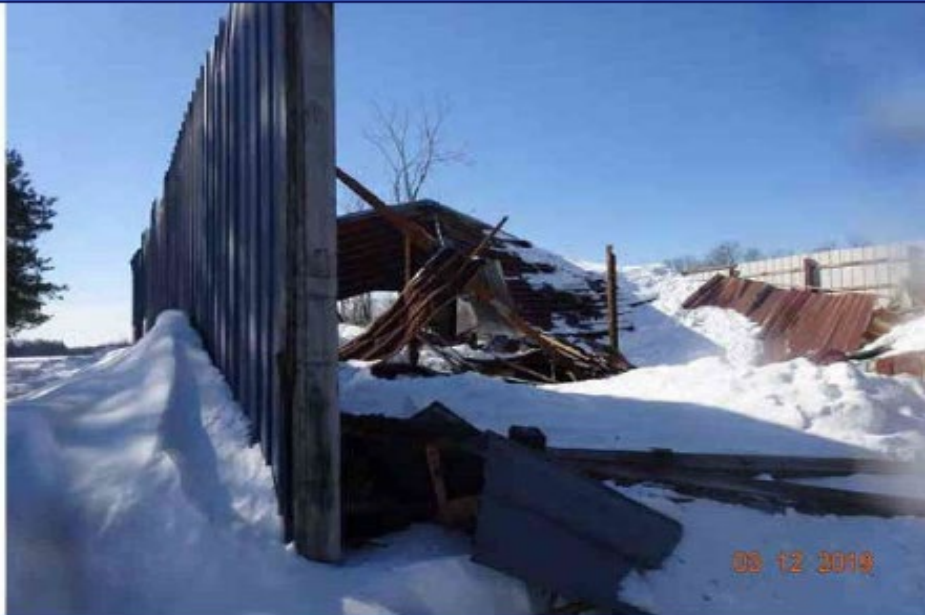
Photo 22: Snow
build-up.

Note: Image
provided by Little
Black Mutual
Insurance.

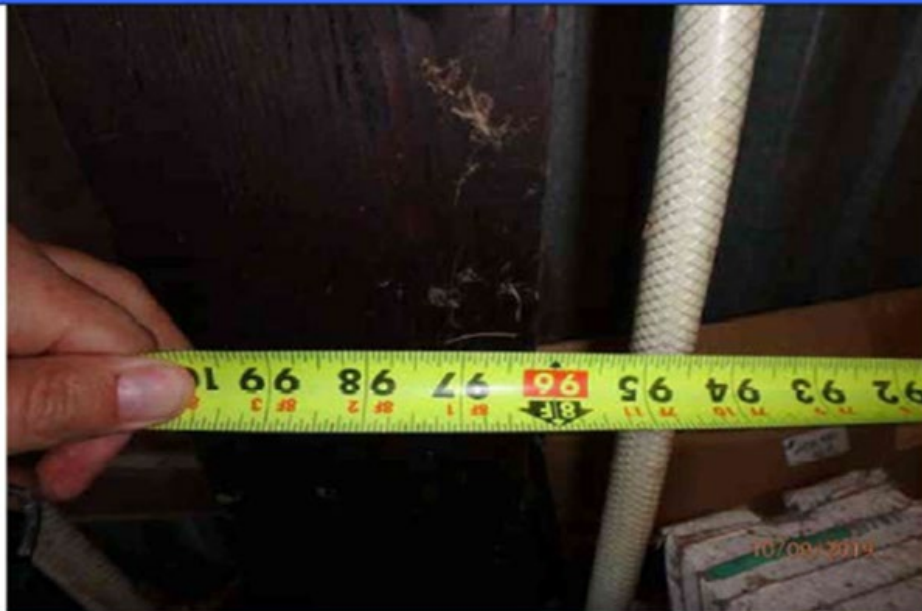
Photo 12: Typical
column spacing
with scale.

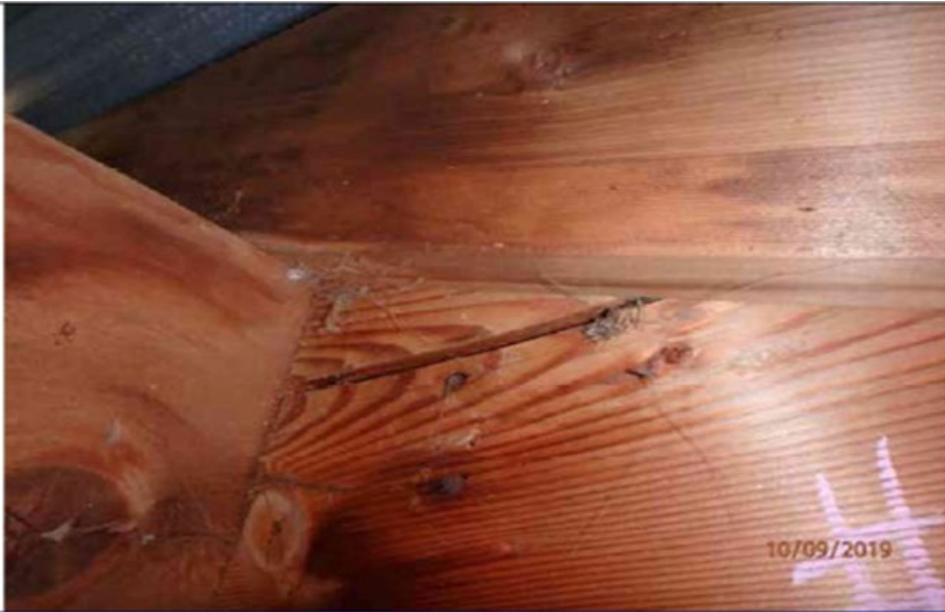
Photo 19: Alternate view of aged fracture in previous photo.

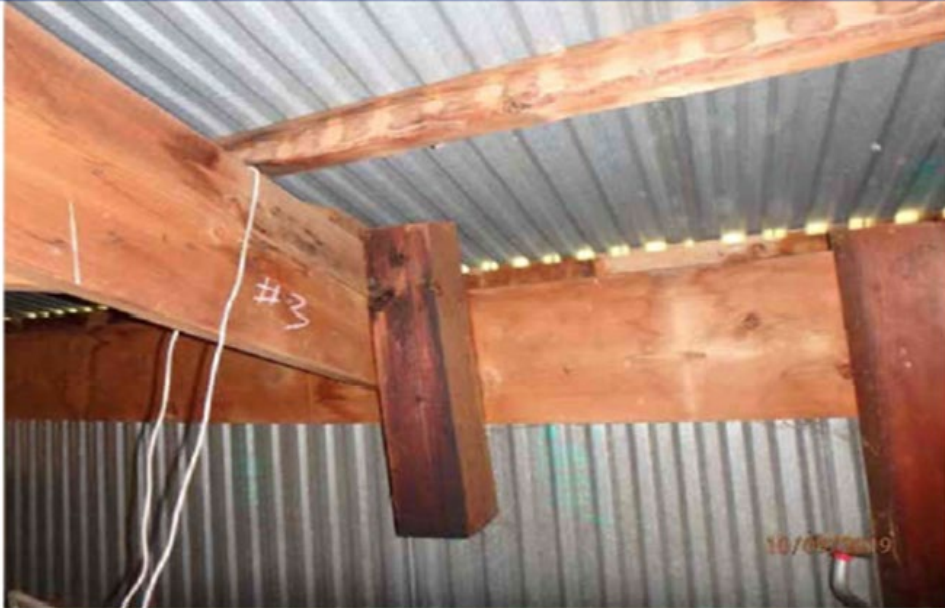
Photo 20: Truncated column and header/ledger board.

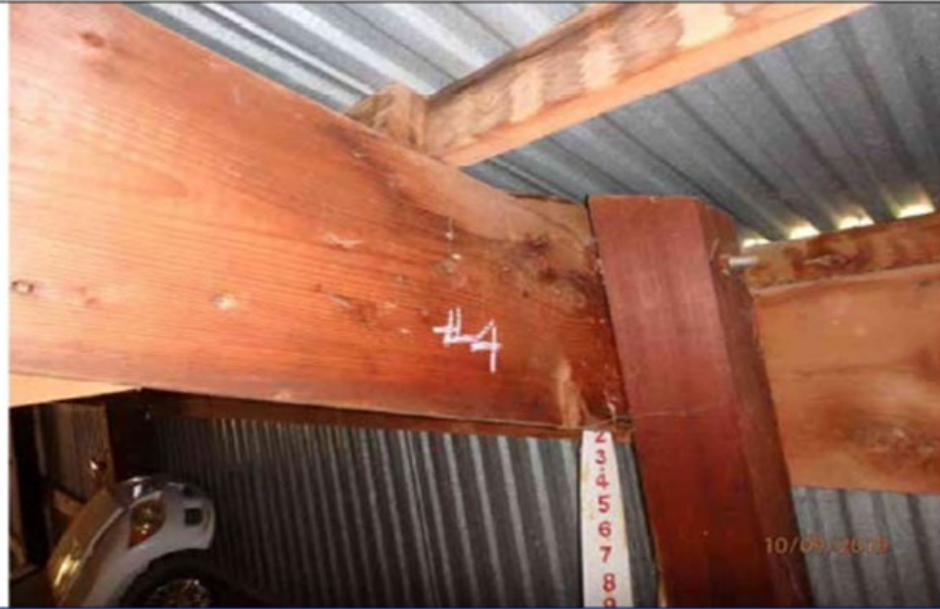
Photo 21:
Horizontal shear
fracture (new
appearance).

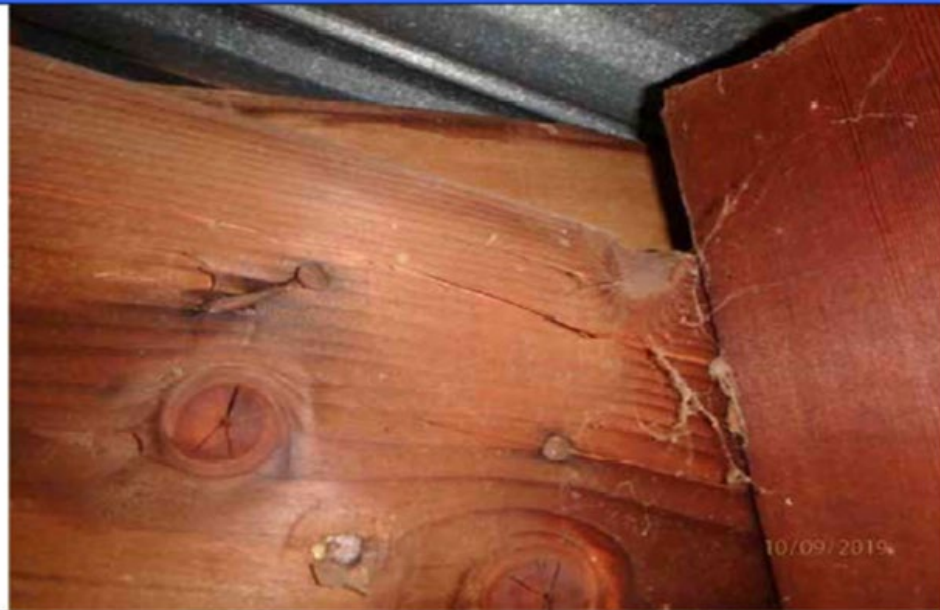
Photo 22: Alternate
view of fracture in
previous photo.

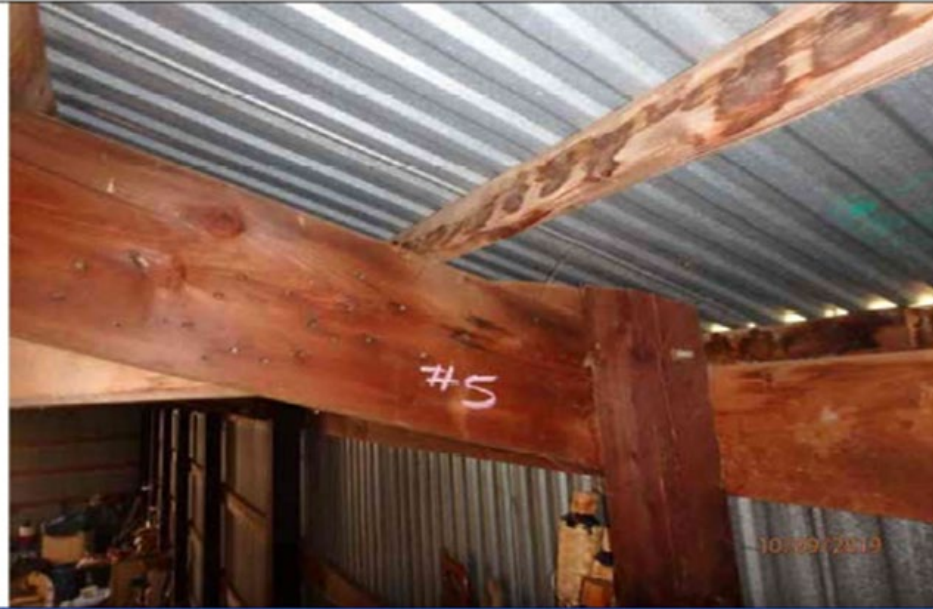
Photo 23:
Horizontal shear
fracture (aged
appearance).

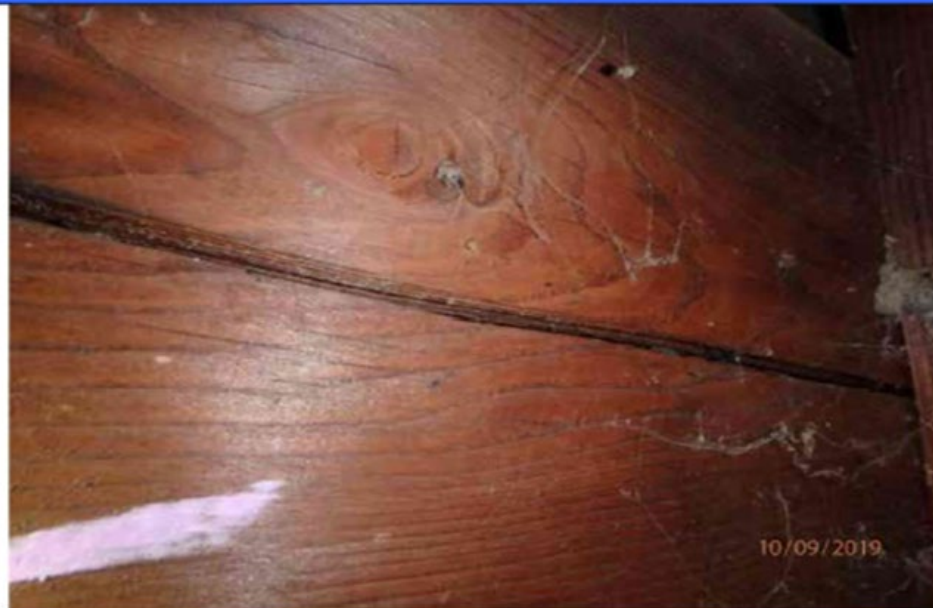
Photo 24: Alternate
view of fracture in
previous photo.

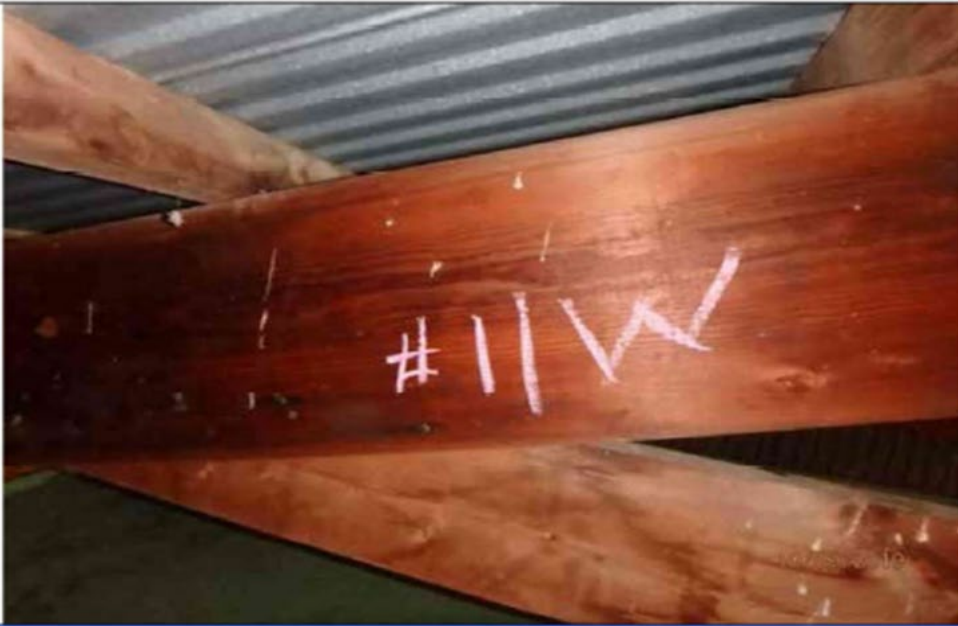
Photo 27:
Horizontal shear
fracture (new
appearance).

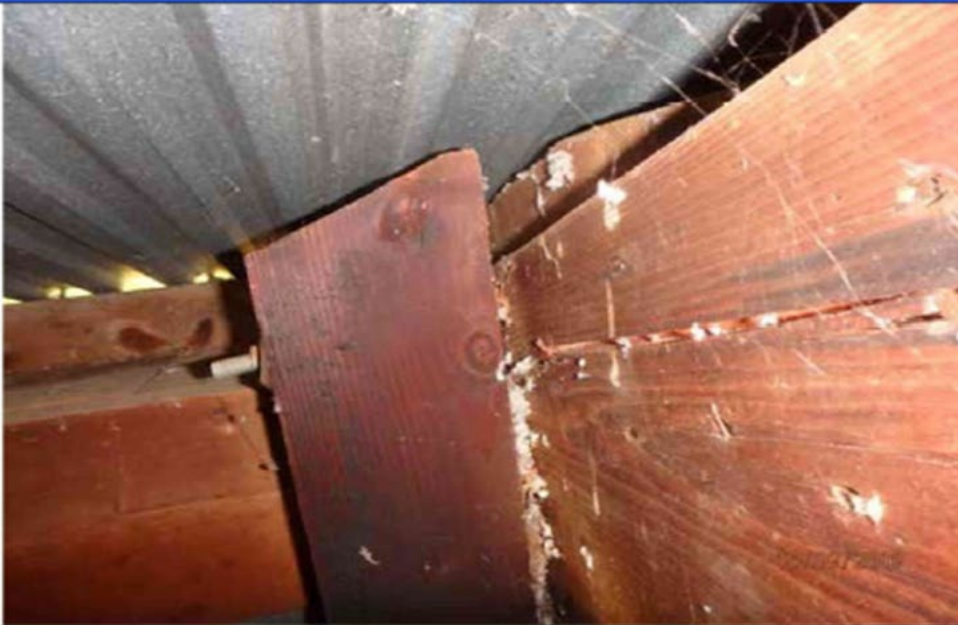
Photo 28: Alternate
view of fracture in
previous photo.
