MLPA 2020

Snow load

Doesn't always mean collapse

It isn't always covered

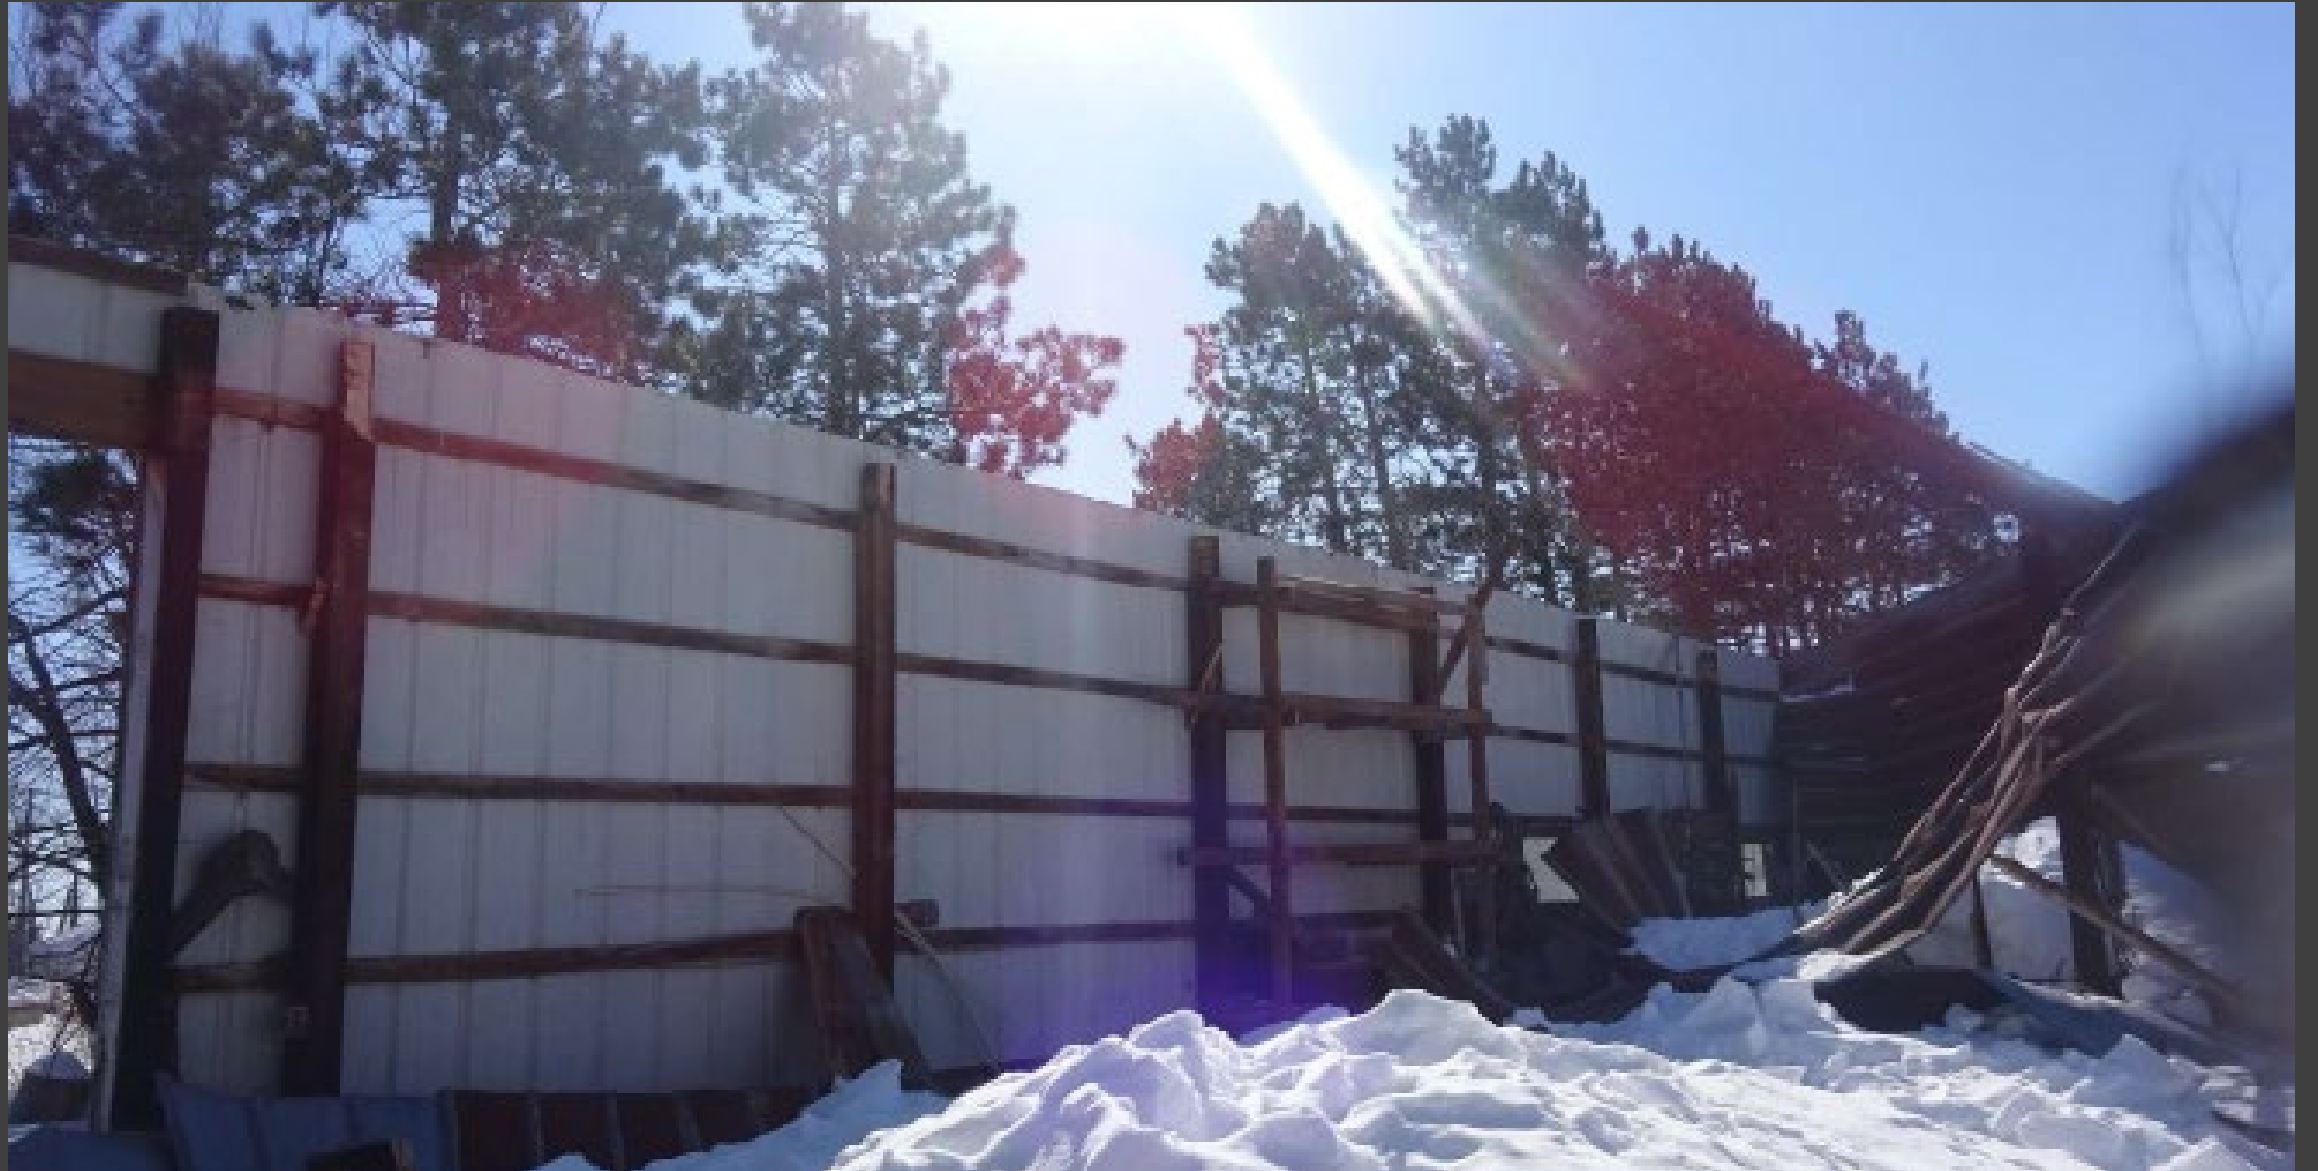
WI Annual Avg Snowfall = 28"
Loss Location Annual Avg = 52"

Snow weight on average:
≥ 20 lbs. per cubic foot*

Multiply snow depth in feet x
weight / cu. ft. =

Total snow load on roof

36.6 lbs. / sf

~22"
Or
1.83'

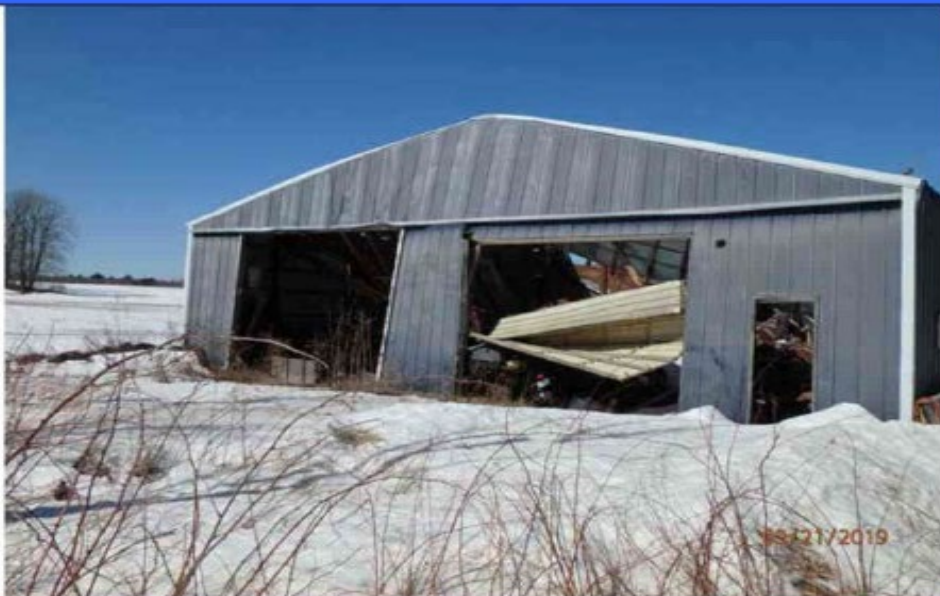
Photo 2: Site identification, street (south) elevation.

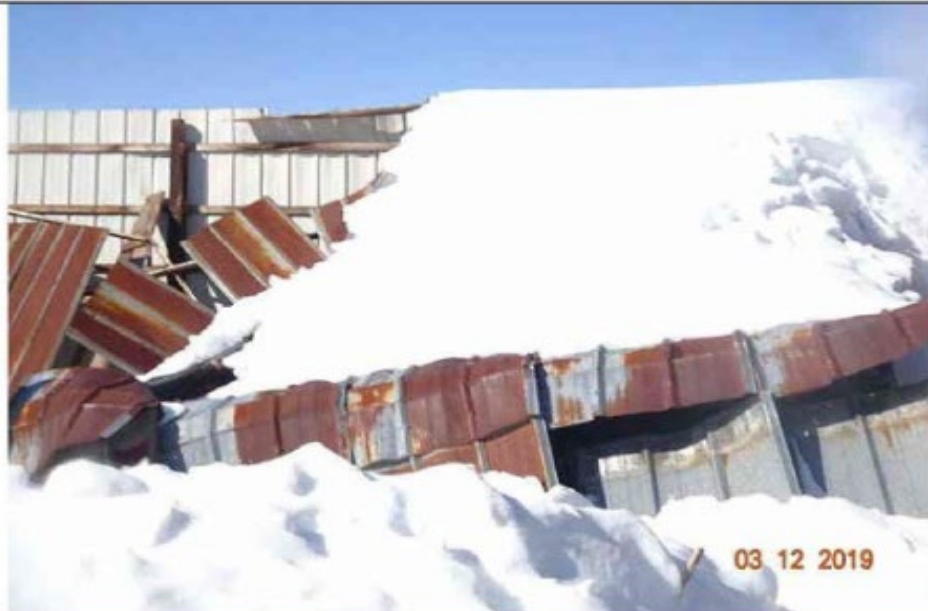
Photo 23: Alternate view of snow build-up.

Note: Image provided by Little Black Mutual Insurance.

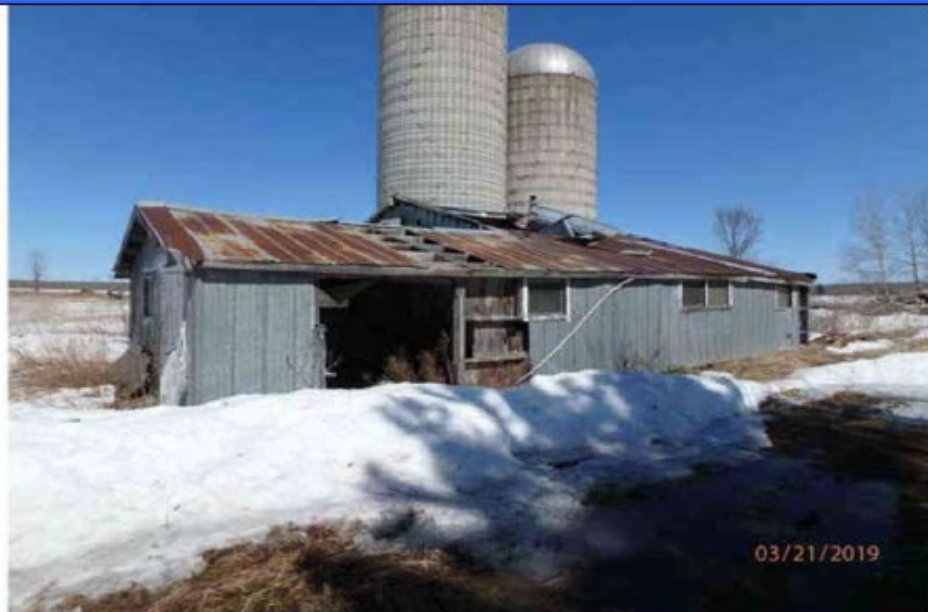
Photo 24: Barn segment with no recently detached cladding.

Note: At detached cladding areas exposed framing displays weathered appearance.

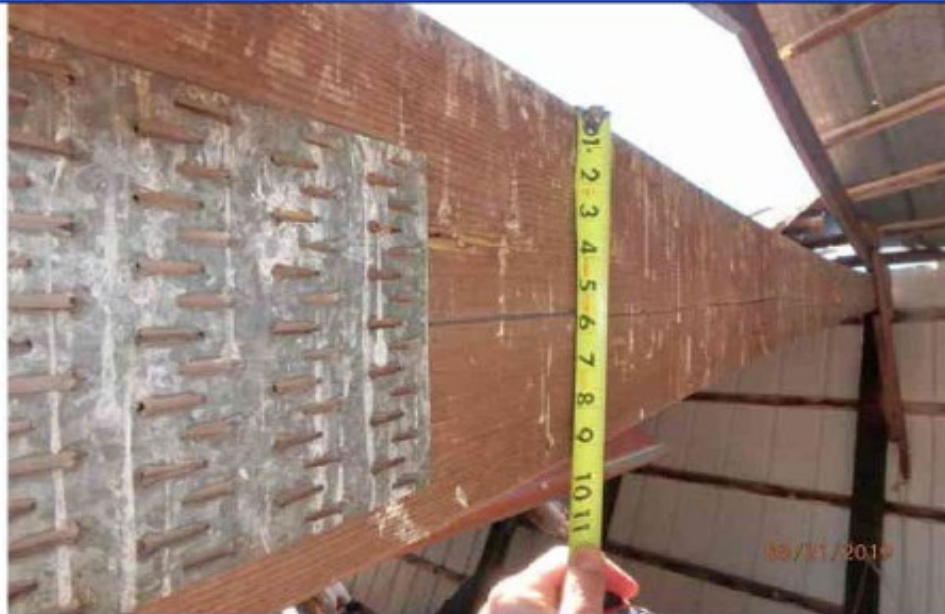
Photo 14: Bottom chord depth with scale.

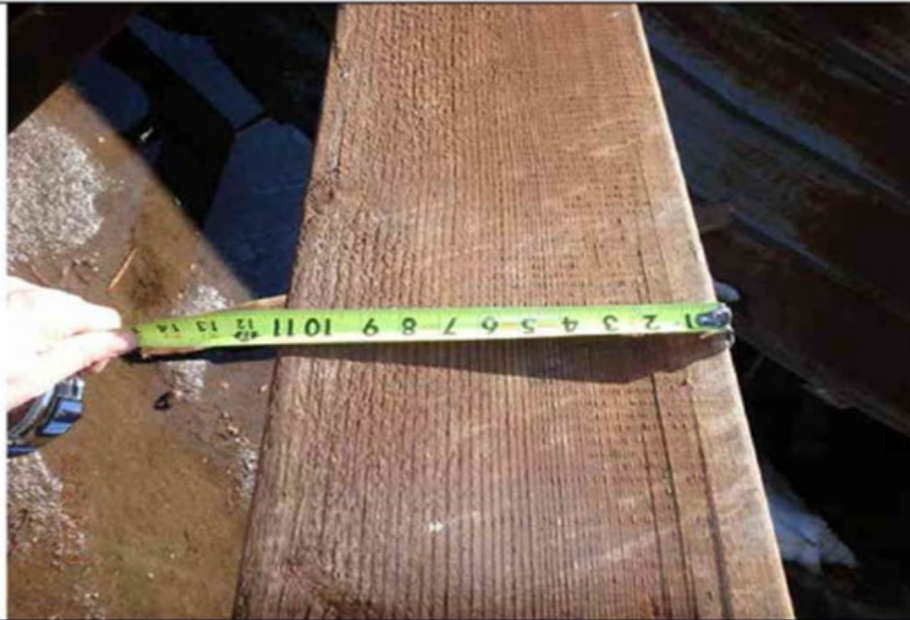
Photo 15: Top
chord depth which
scale.

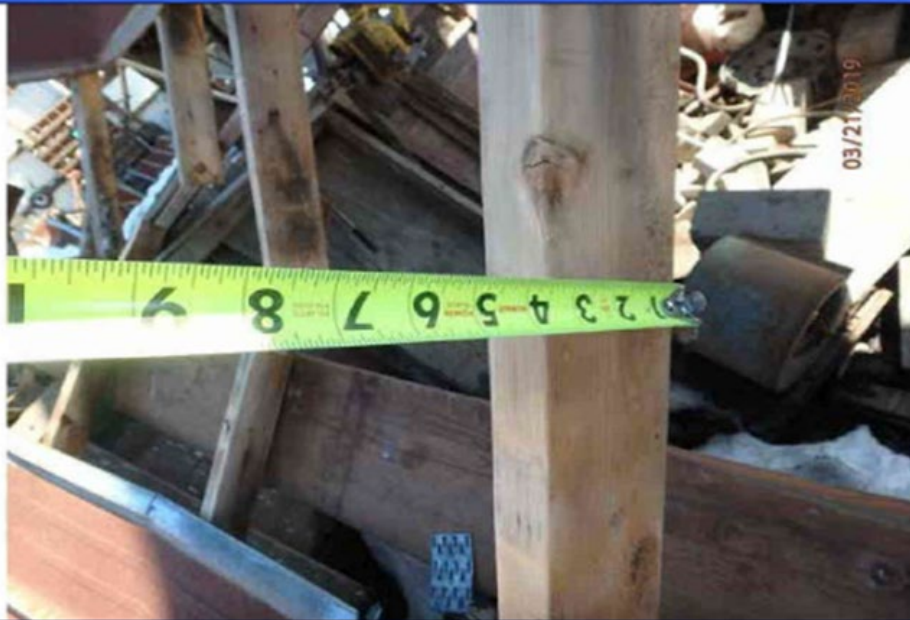
Photo 16: 2x4
purlin,

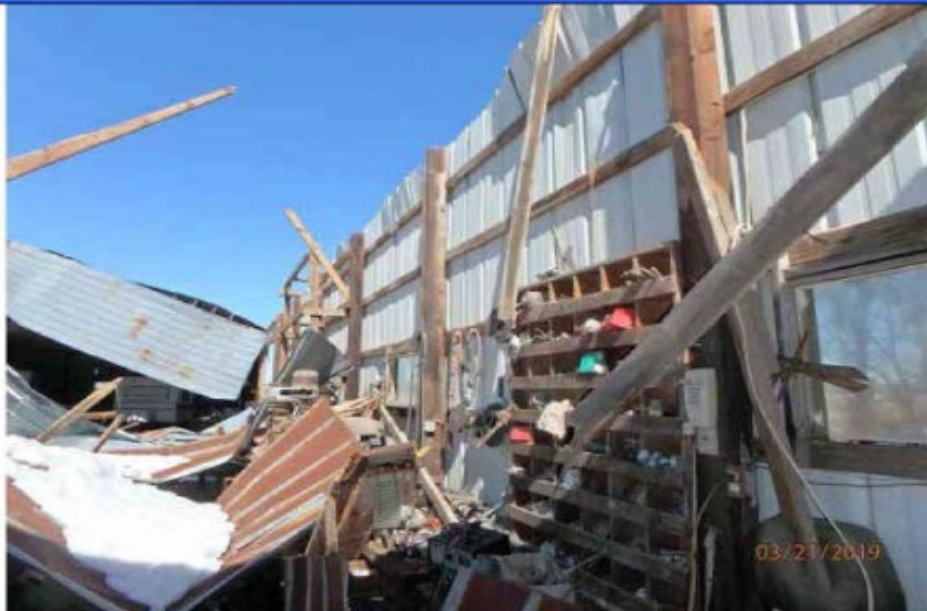
Photo 20:
Displaced columns
and deformed
panels.

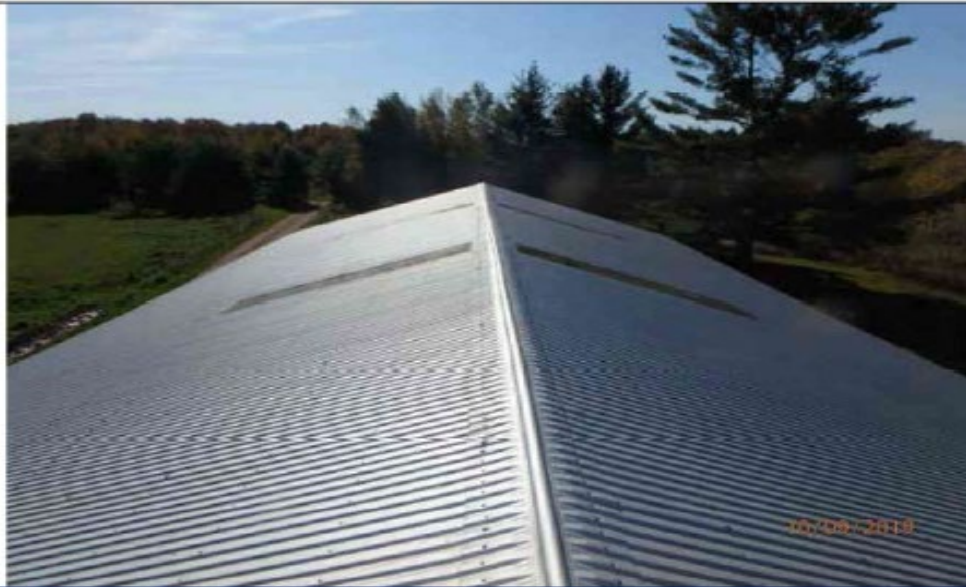
Photo 6: Sealant.

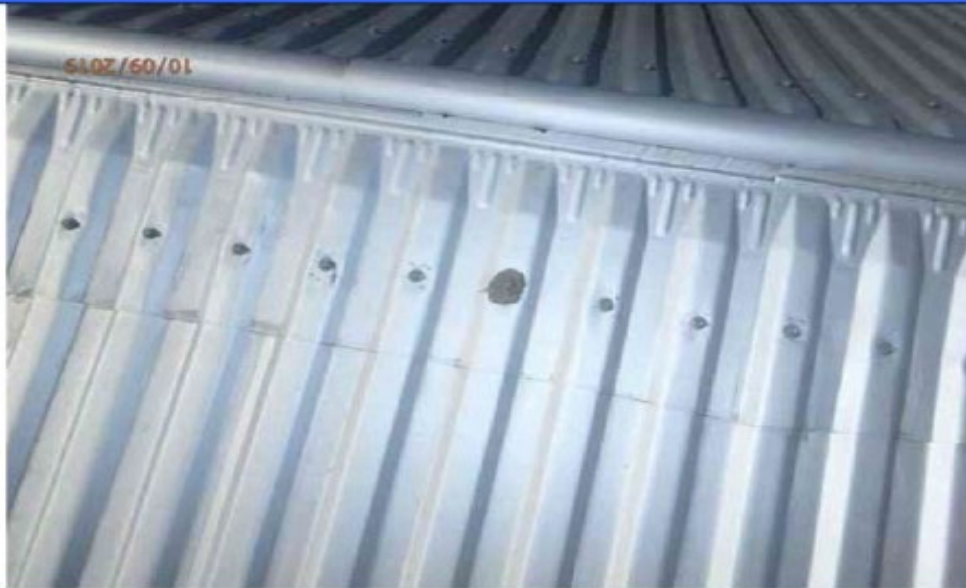
Photo 7: Sealant at panel side lap.

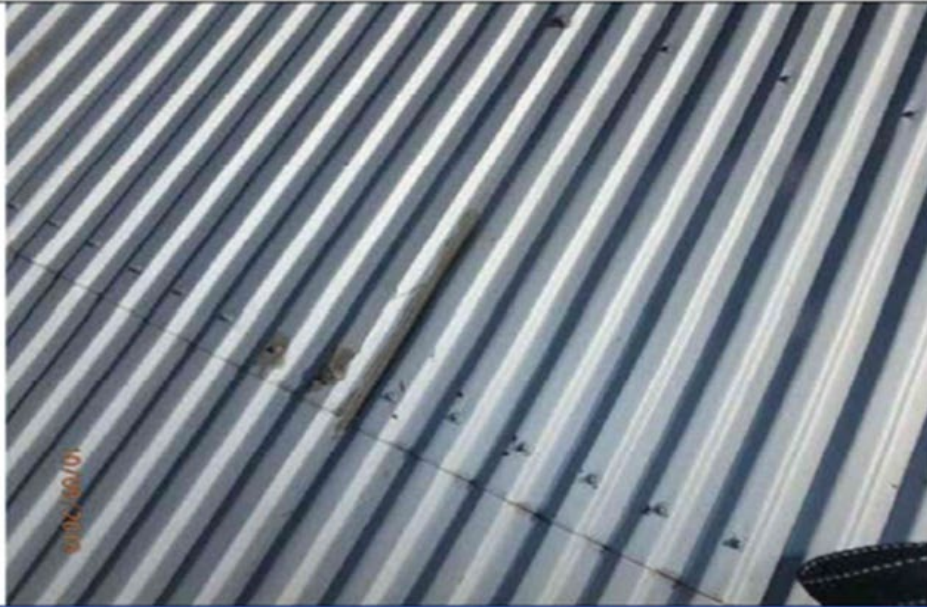
Photo 8: Multiple fasteners.

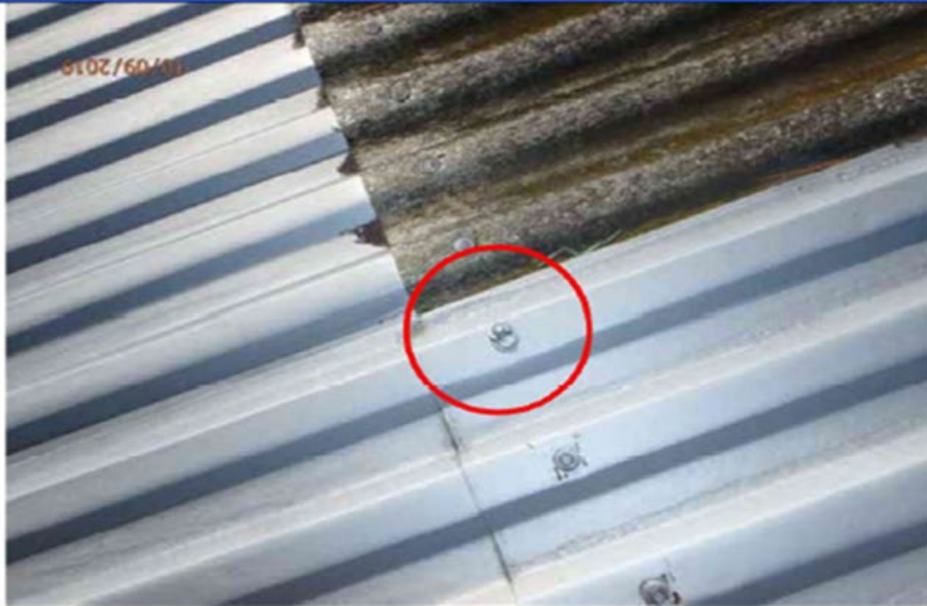
Photo 9: Panel indentations.

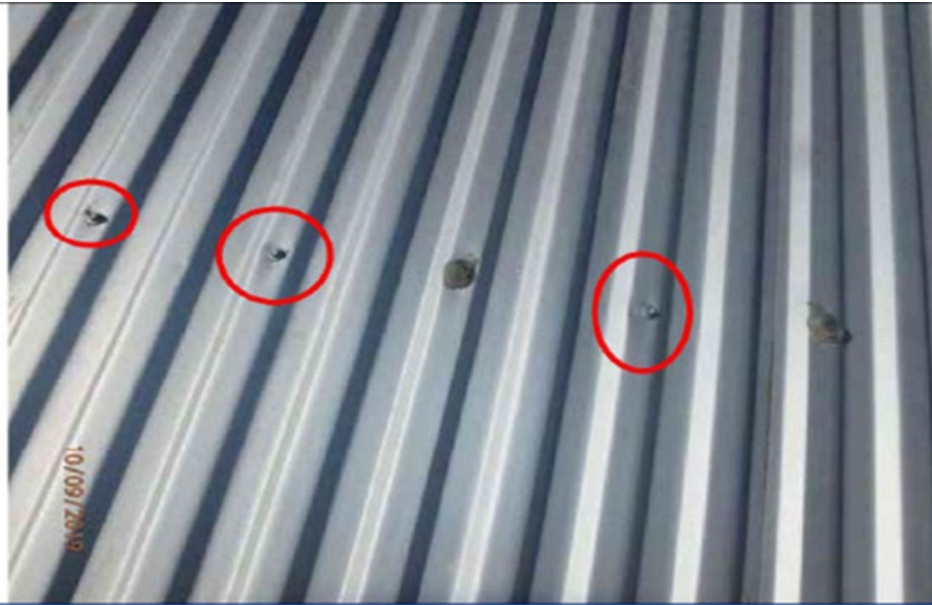
Photo 10: Typical roof framing.

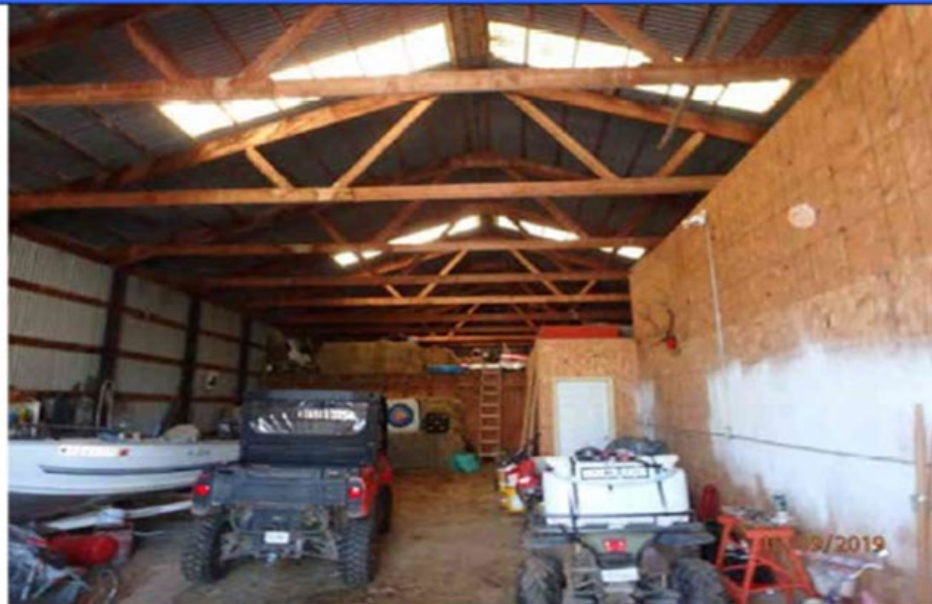
Photo 3: South elevation.

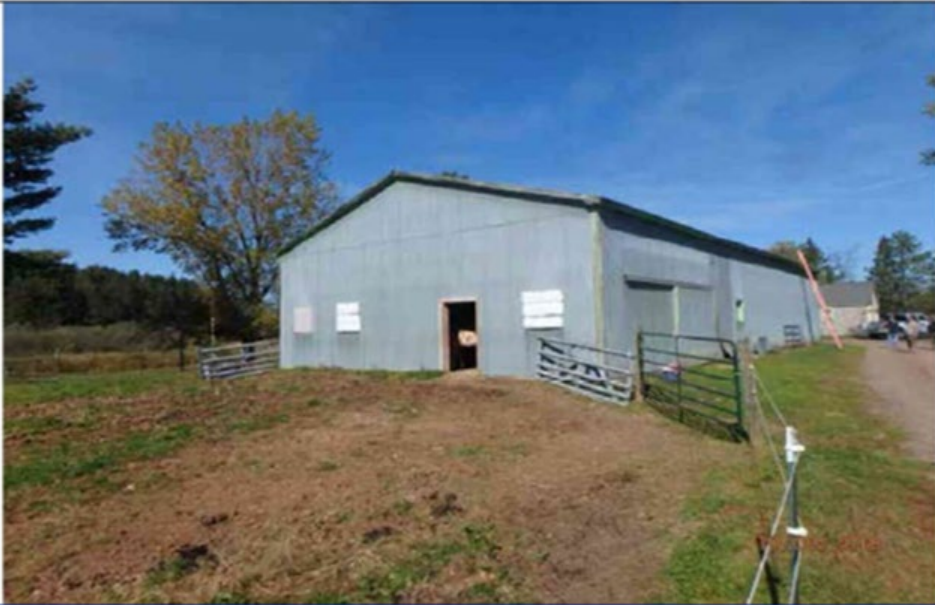
Photo 4: East elevation.
